Changes in Ionizing Radiation Field During the First Cycle after Zinc Injection into the Primary Circuit of Operating Nuclear Power Units

CNNC Nuclear Power Operation Management Co., Ltd
October 2025

Radiation Monitoring of Zinc Injection into the Primary System at Fangjiashan Unit

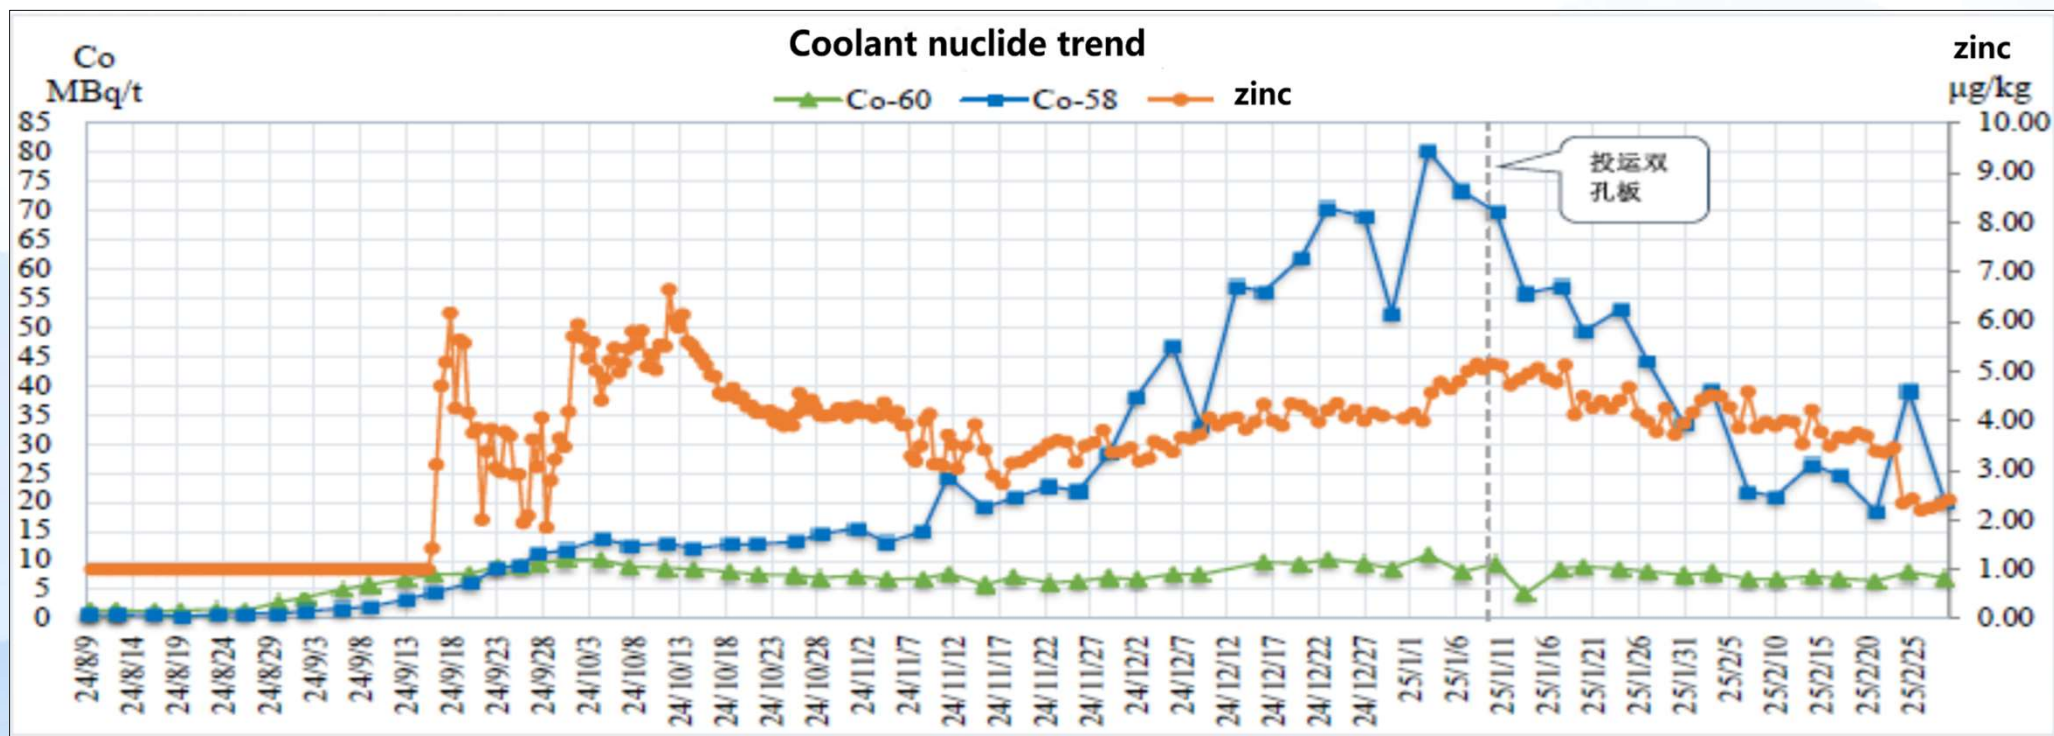
KRT radiation monitoring of the chemical and volume control system letdown piping

- To address the rapid increase of Co-60 and Co-58 nuclides in the primary system coolant, the unit activated the second letdown orifice plate train ahead of schedule.
- With the increase in purification flow rate, the specific activity of Co-60 and Co-58 nuclides in the primary system coolant showed a significant downward trend.
- Sufficient purification reduced the deposition of activated corrosion products in the system.

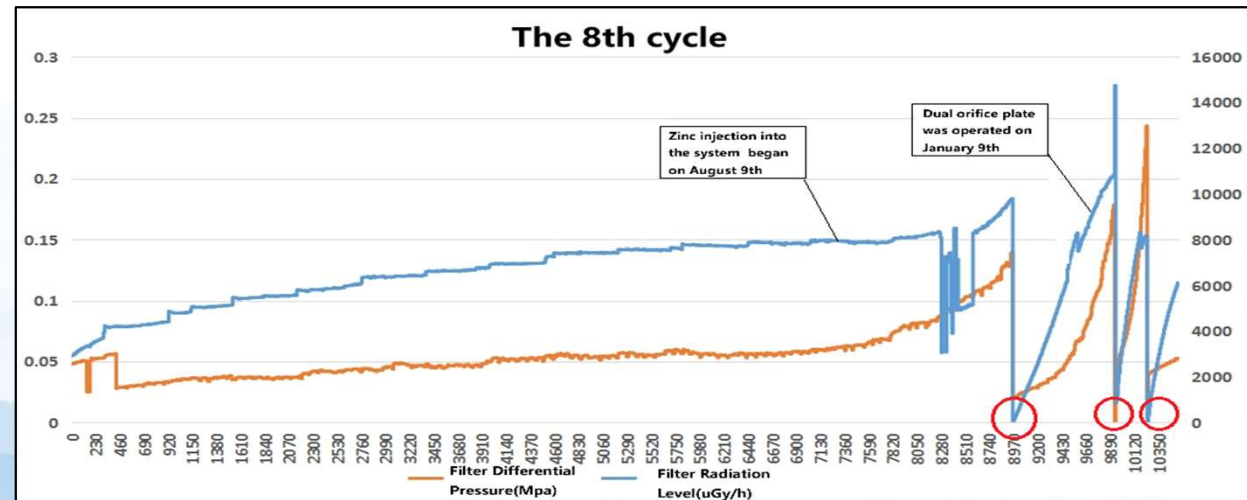
Monitoring of the Pre-filter for the Chemical and Volume Control System Purification Bed (1RCV010FI)

- Monitoring the radiation level of the pre-filter during operation. In the 7th and earlier fuel cycles, typically 0 to 1 pre-filters were replaced over the entire operation cycle.
- In the 8th fuel cycle, a total of 3 pre-filters were replaced before the outage.
- After zinc injection, the activated corrosion products significantly increased and were subsequently purified.

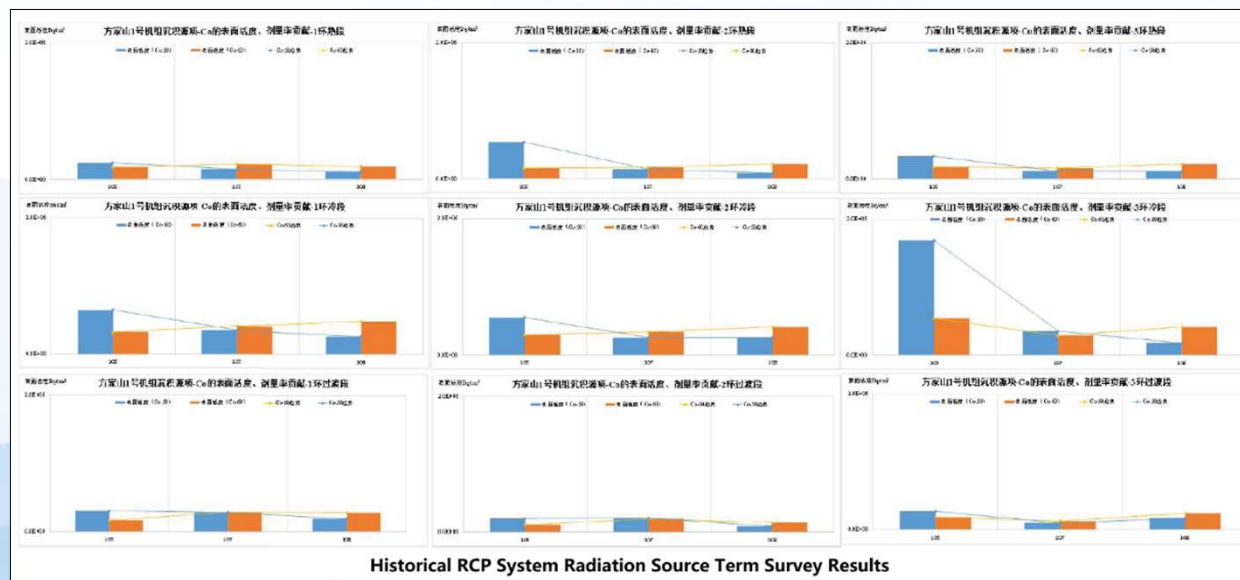
Measurement of deposited radiation source terms during outage

- After one zinc-injection cycle, in 108 outage, the deposition of Co-58 in the main pipeline of RCP system showed a decreasing trend. The deposition of Co-60 exhibited a slight upward trend.
- This indicates that the first zinc-injection operation had a certain impact on reducing deposited source terms.
